Subject: **Information against Containment for MET turbocharger**

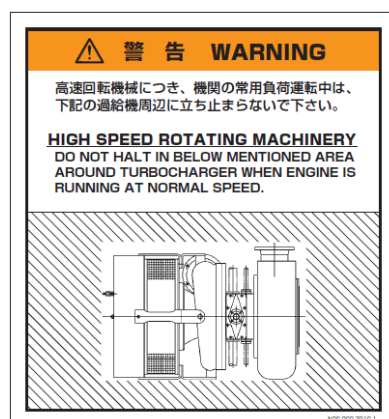
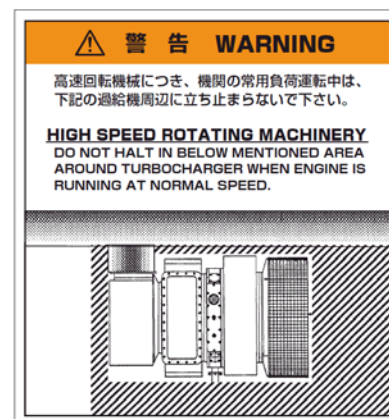
Fig.1 Warning label

Regarding the “Off Limits Area” around turbocharger, necessary warning label is attached on the turbocharger itself and explanation is indicated in the instruction manual for currency turbocharger. On the other hand, more severe containment requirement was issued by regulation amendment of IACS 2016.

To comply with this requirement, MHI issue this paper not to close the turbocharger during normal operating period.

Recommendation to reduce the risk.

- ① Surely perform regular maintenance works followed the instruction manual
- ② Keep within Max. permissible speed and max. allowable temperature.
- ③ No use of low quality fuel oil (To prevent unbalance of rotor shaft caused by fouling and/or over-run caused by firing of the unburnt fuel oil at downstream of the engine)
- ④ No use of low quality lubricating oil
- ⑤ NDT(PT) around claw clutch before reassembly of impeller wheel.
- ⑥ Confirmation of the rotor shaft end bending (within 0.1mm) after completion of impeller wheel reassembly.
- ⑦ Correct tightening force followed instruction manual and confirmation of the distance between rotor shaft end and tightening nut end.(Refer to the instruction manual for more detail)
