# IMPROVING STEAM TURBINE RELIABILITY

Implementing phased array ultrasonic testing (PAUT) in turbine inspection and maintenance marks an evolution from traditional maintenance to more advanced solutions that ensure efficiency and reliability.

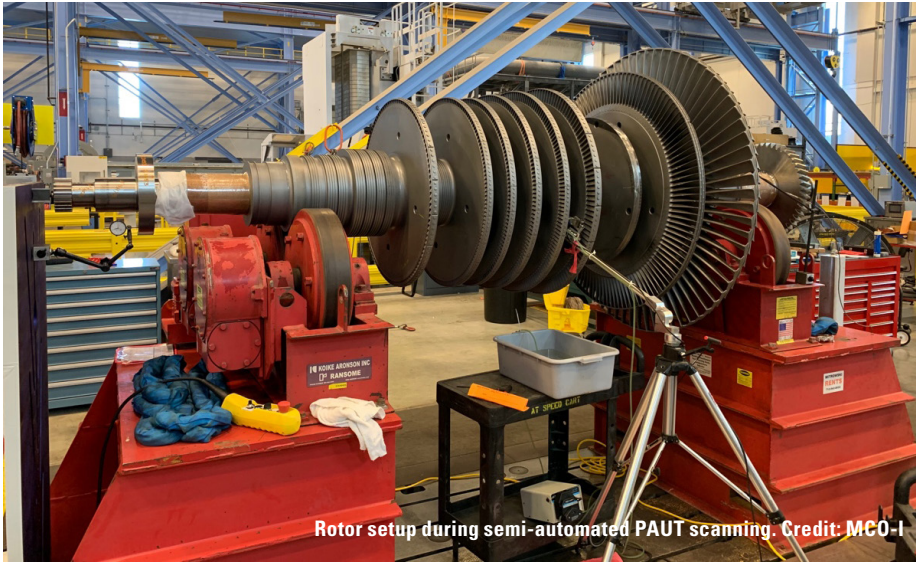
Rotor setup during semi-automated PAUT scanning. Credit: MCO-I
